UNDERWATER BRIDGE INSPECTION REPORT

STRUCTURE NO. 18510

DAGGETT CHANNEL

DISTRICT 3 – CROW WING COUNTY

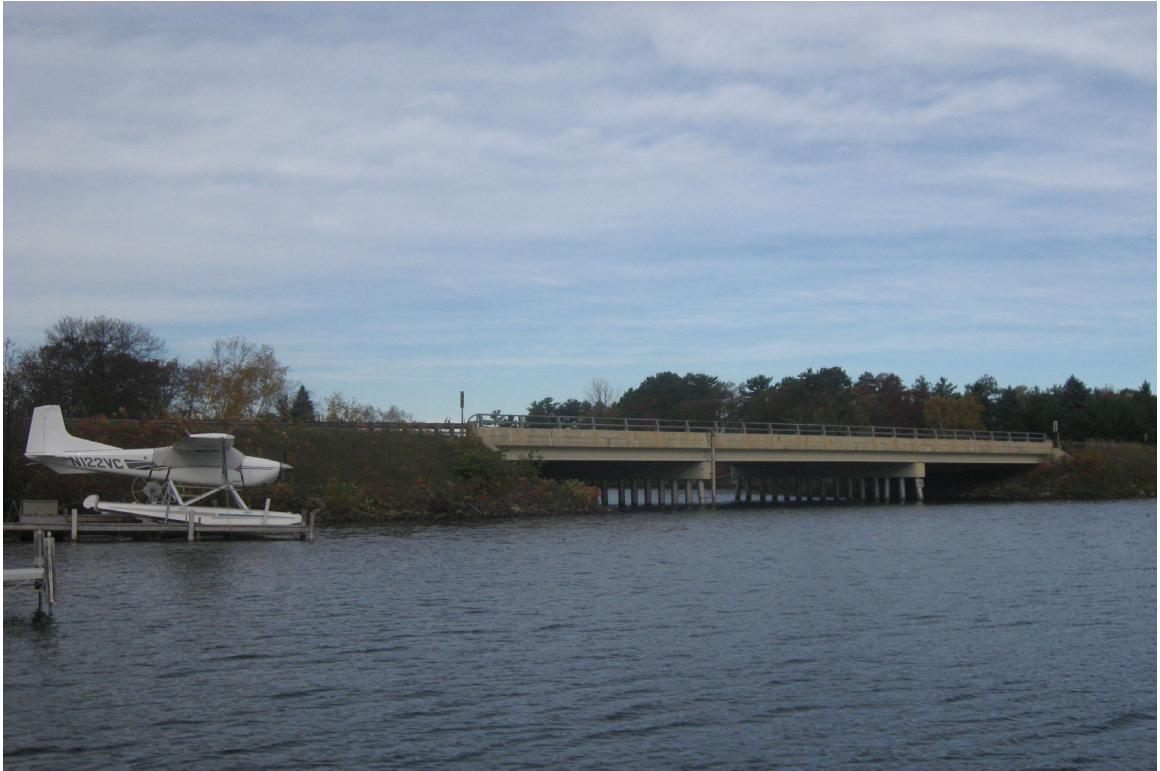
Photograph 1. Overall View of the Structure, Looking Northwest.

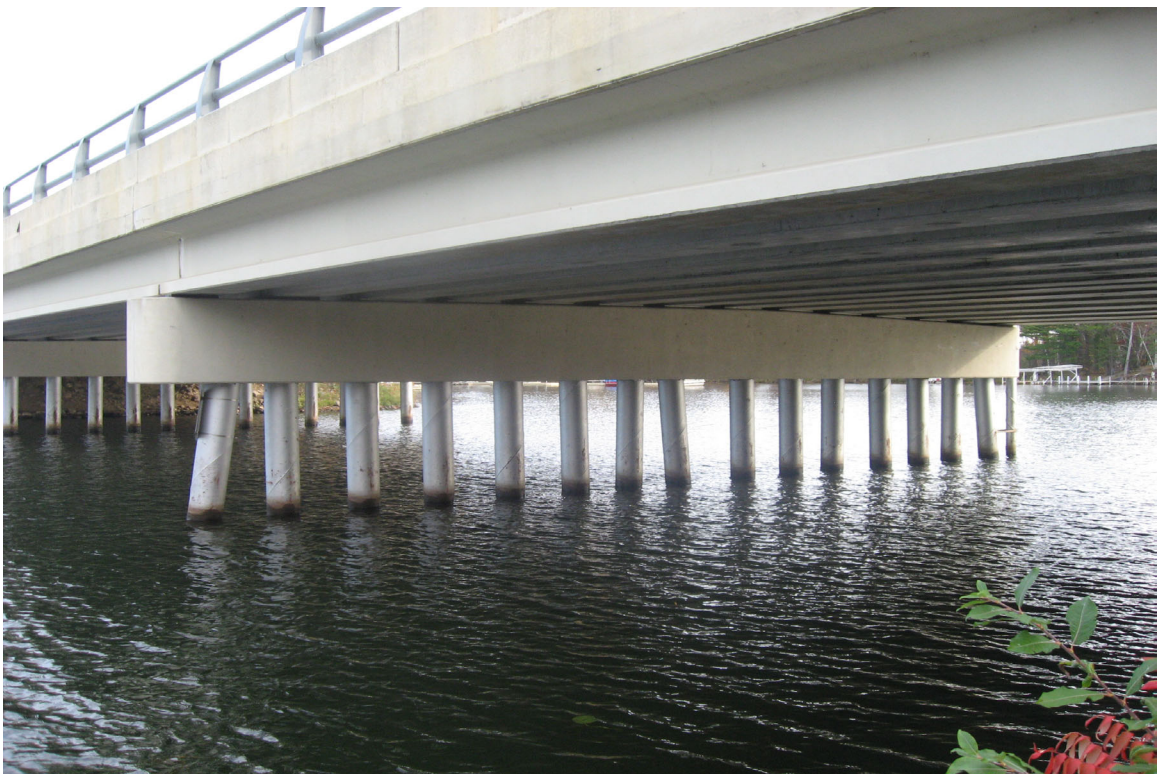
Photograph 2. View of Pier 1, Looking Northeast.

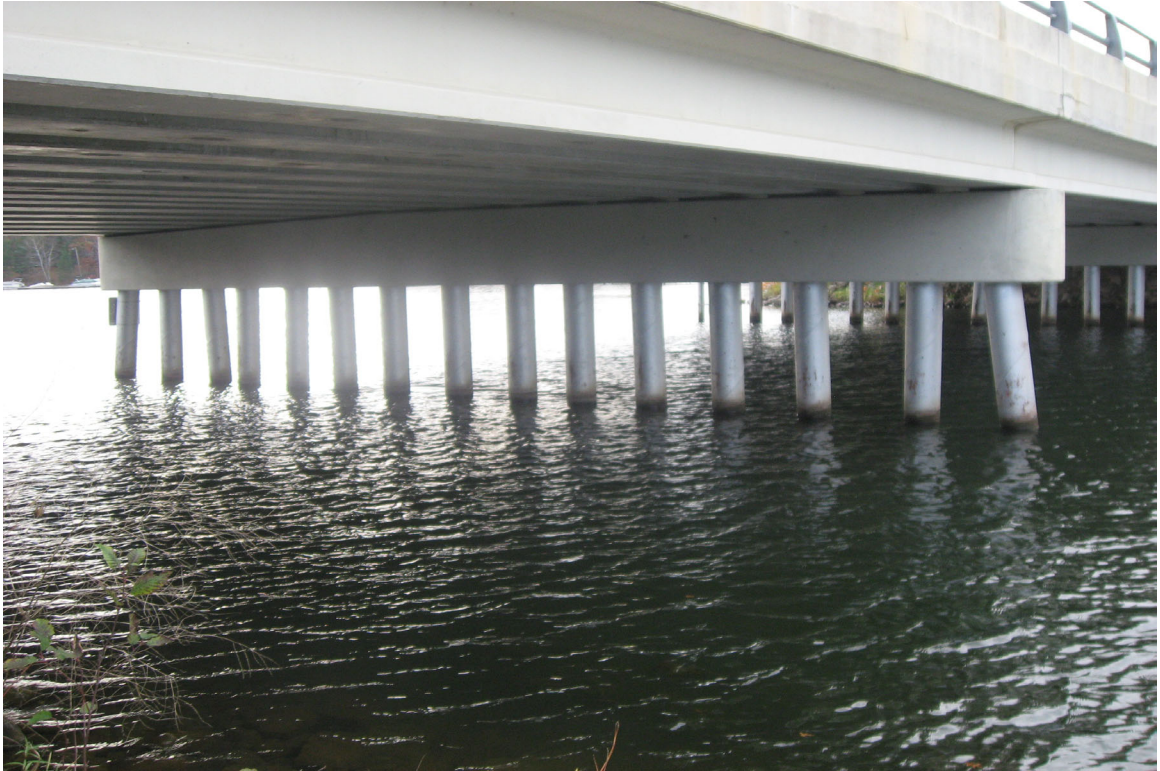
Photograph 3. View of Pier 2, Looking Southeast.

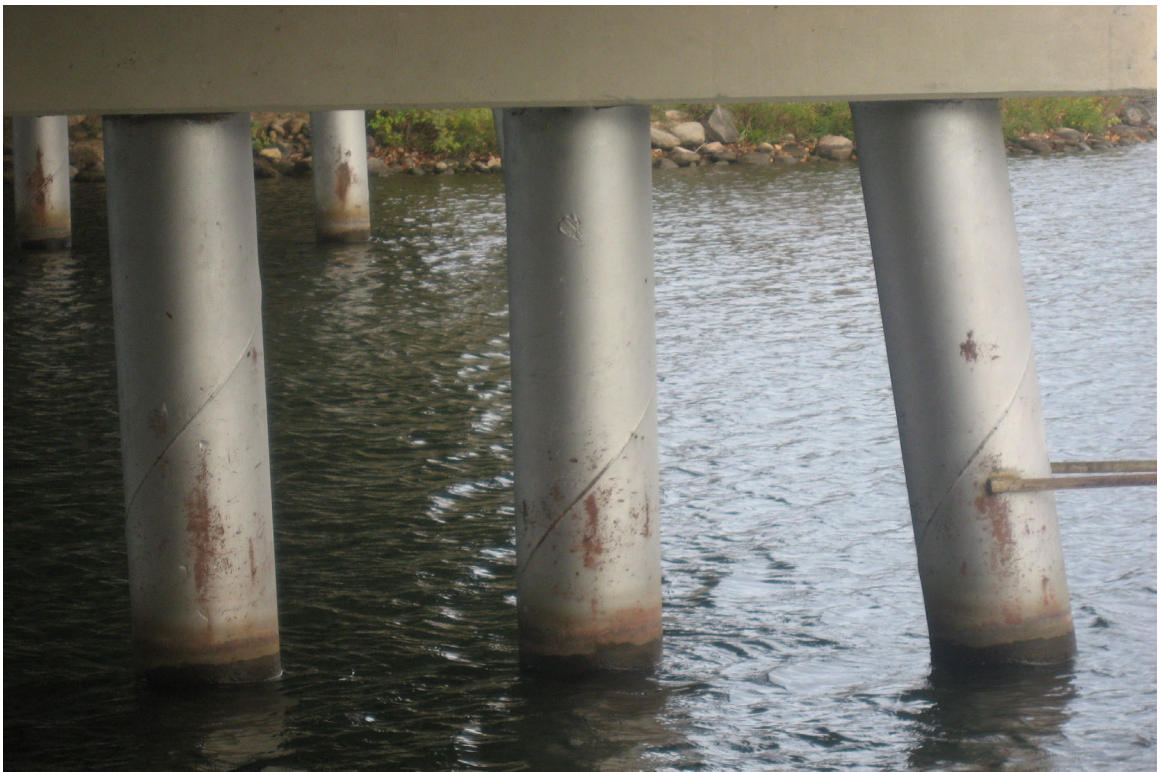
- (A) The piles of Piers 1 and 2 exhibited coating loss from approximately a maximum of 9 inches above the waterline to the channel bottom with up to 30% of the surface area covered with rust nodules that exhibited 1/2 to 1 1/2 inch maximum diameter. The piles exhibited only minor pitting and minimal section loss up to 1/32 inch deep as a result of the present extent of corrosion.

Photograph 4. Piles 1, 2, and 3 at the upstream end (East side) of Pier 1, Looking North.

- (A) Reinspect the submerged substructure units at the normal maximum recommended (NBIS) interval of five (5) years.

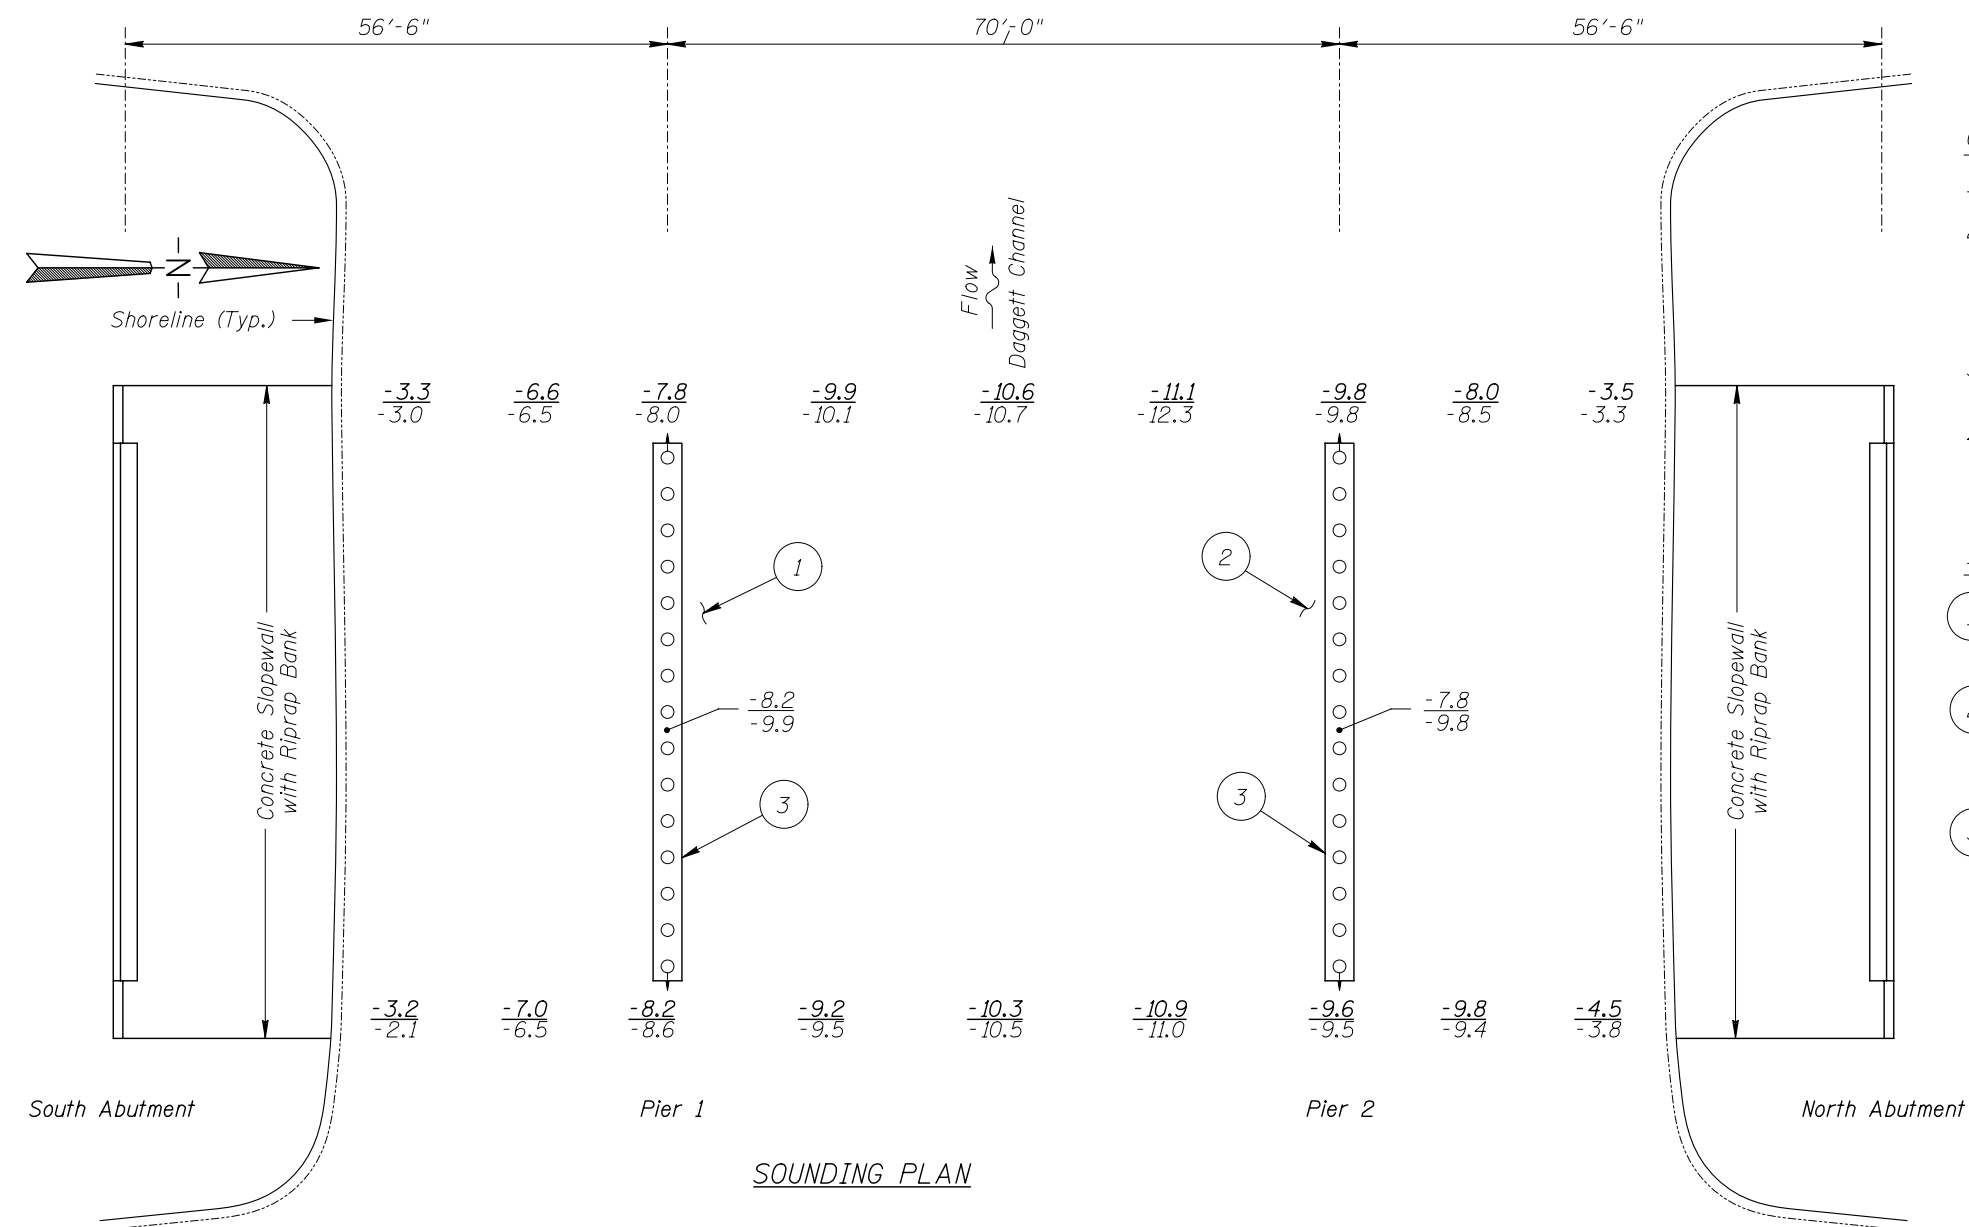
INSPECTION AND SOUNDING PLAN

- The channel bottom around Pier 1 consisted of sand with 6 to 8 inches of probe rod penetration.
- The channel bottom around Pier 2 consisted of sand and 6- to 8-inch-diameter cobbles with 6 to 8 inches of probe rod penetration.
- Piers 1 and 2 exhibited coating failure and surface corrosion from a maximum of approximately 9 inches above the waterline to the channel bottom on approximately 30 percent of the surface area with 1/2-inch to 1.5-inch-diameter rust nodules and minimal section loss with pitting up to 1/32 inches deep.
